March 1, 2013

Re: Delineation of the Higginbottom Cemetery at Lake Land' Or, Caroline County, Virginia.

Project Methodology

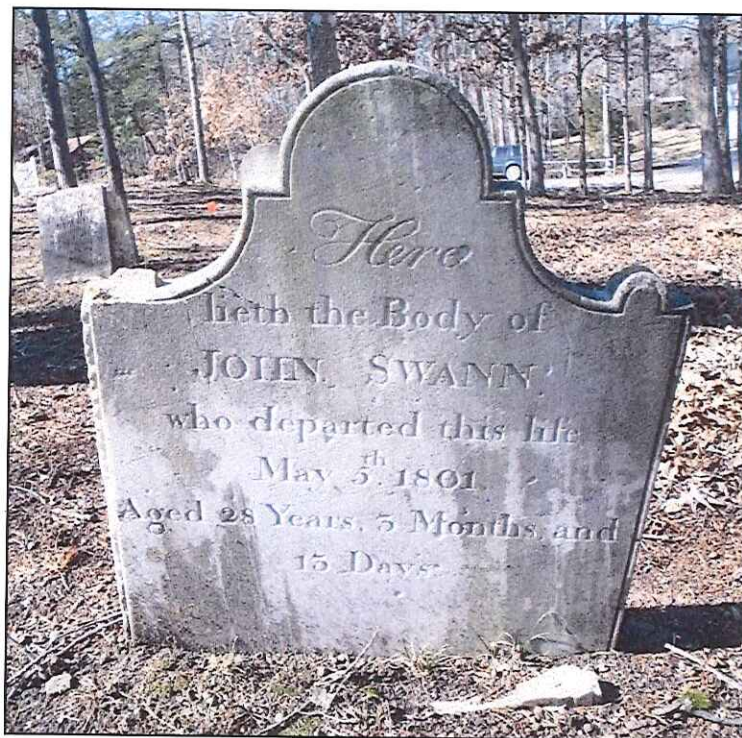
Photo 1: Headstone for John Swann.

Ground depressions initially identified as possible graveshafts observed within the area generally range between 4 to 6 feet long and 1.5 to 3 feet wide. Five ground depressions have associated headstone/footstone markers. Headstones observed during the surface inspection are associated with a matching footstone. These footstones are assumed to be matched sets based on inscribed initials corresponding to the headstones. The majorities of these headstones identified are broken near the base and have subsequently been repositioned upright at the head of the associated grave. These are generally oriented east-west with headstones located on the west of the graveshaft and a footstone at the east. A matched set of headstone and footstone with the engravings "Hill Jones" and corresponding initials of "H. J." on the footstone are not located facing each other flanking a depression in the ground. The footstone is currently positioned next to headstone at the head position of an adjacent depression. The footstone appears to have been relocated to its current position and may not accurately represent or be associated with the potential grave depression at this location. One set of grave markers associated with "John Swann" does not appear to have an associated ground depressions located between the set of markers.

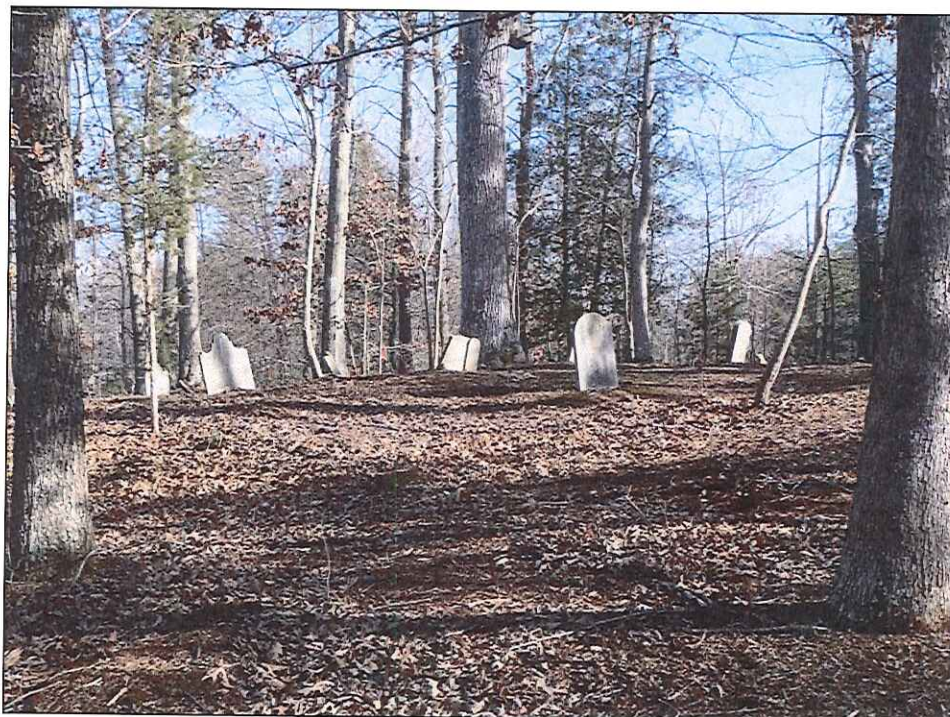
Photo 4: View of Cemetery Plot, Facing Southeast.

The cemetery is located on the east facing edge of a flat ridge top overlooking the shores of Lake Land'Or (Figure 2, p. 6; Photo 4, p. 6). The topography of this location is nearly level and situated in a small wooded area between developed residential parcels (Figure 3, p. 7). The cemetery has been regularly cleared of intrusive trees and excessive undergrowth by residential neighbors and is generally covered by thick mat of leaf litter. A mature Dogwood tree is situated near the general epicenter of the cemetery plot which currently contained some smaller tree saplings within the plot and some larger pine at the periphery. The initial surface inspection identified approximately 20 depressions, five headstones, four footstones, and four fieldstones. The ground depressions observed within the study area were found to be laid out in a nearly east-west alignment across four rows. The proposed study area for this cemetery delineation includes areas between the previously identified ground depressions and extends toward the peripheries in order to better determine the cemetery boundary limits.

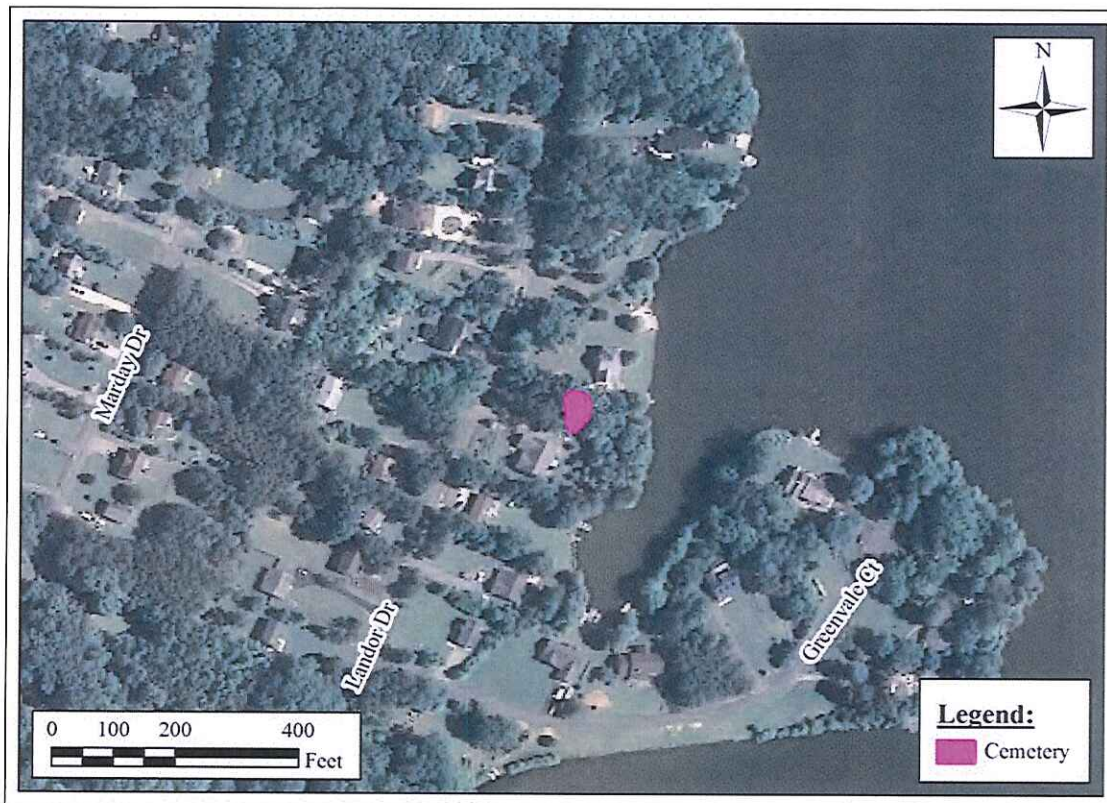
Figure 3: Location of the Higginbottom/Lake Land'Or Cemetery on the 2011 National Agricultural Imagery Program Aerial (USDA 2011).

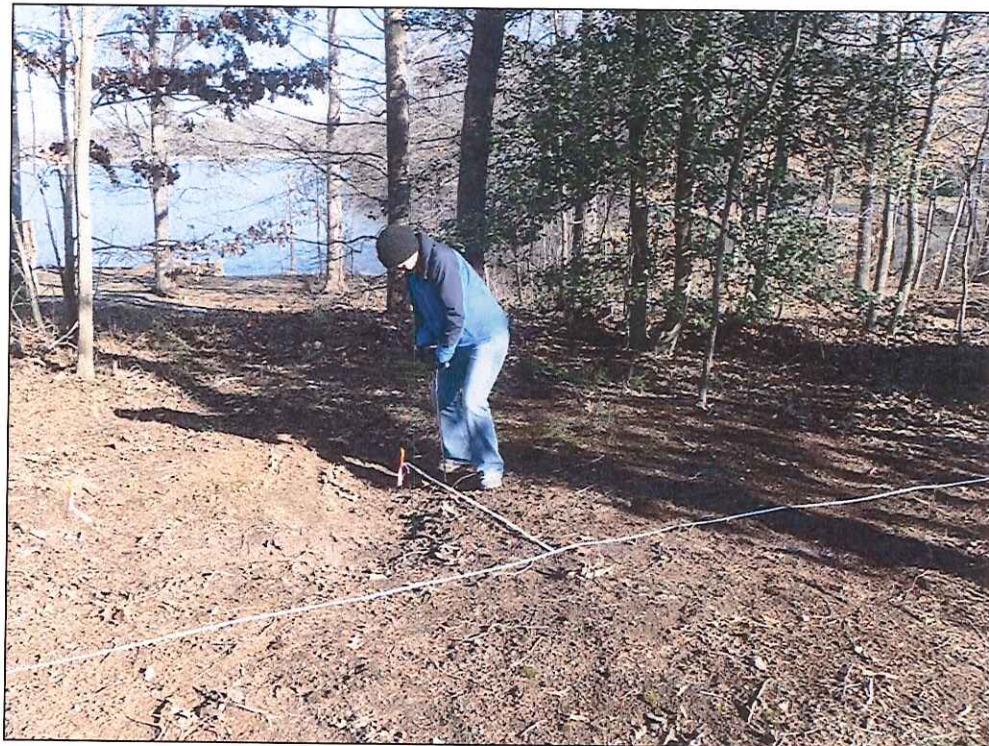
Photo 5: Caitlin Oshida Conducting the Penetrometer Survey Within the Study Area.

Each grave marker was recorded and photographed and approximate measurements were taken in order to draw a sketch map of the location of each grave within the study area. A penetrometer survey was recommended in order to aid in identifying additional graves that could not be visibly confirmed during the surface inspection (Photo 5, p. 8). The penetrometer survey was used to delineate the boundaries of the cemetery and the individual graves. The penetrometer survey measured the compaction of soil across the cemetery plot. Soil compaction of natural soil strata that have been disturbed will generally produce a low compaction reading. This is generally a result of the soil particles that have been removed and rearranged creating voids in the fill materials. The penetrometer was first calibrated with readings from known sunken graveshafts at this cemetery with those taken from locations not suspected to be burial locations. Suspected graves within this plot typically produced a compaction reading under 150 PSI (pounds per square inch) while non-grave areas produced readings over 150 PSI.
